## **Limited Visual Dam Safety Inspections**

**Summary ReportA-085**

**HC&S Reservoir 80**

**Maui, Hawaii**

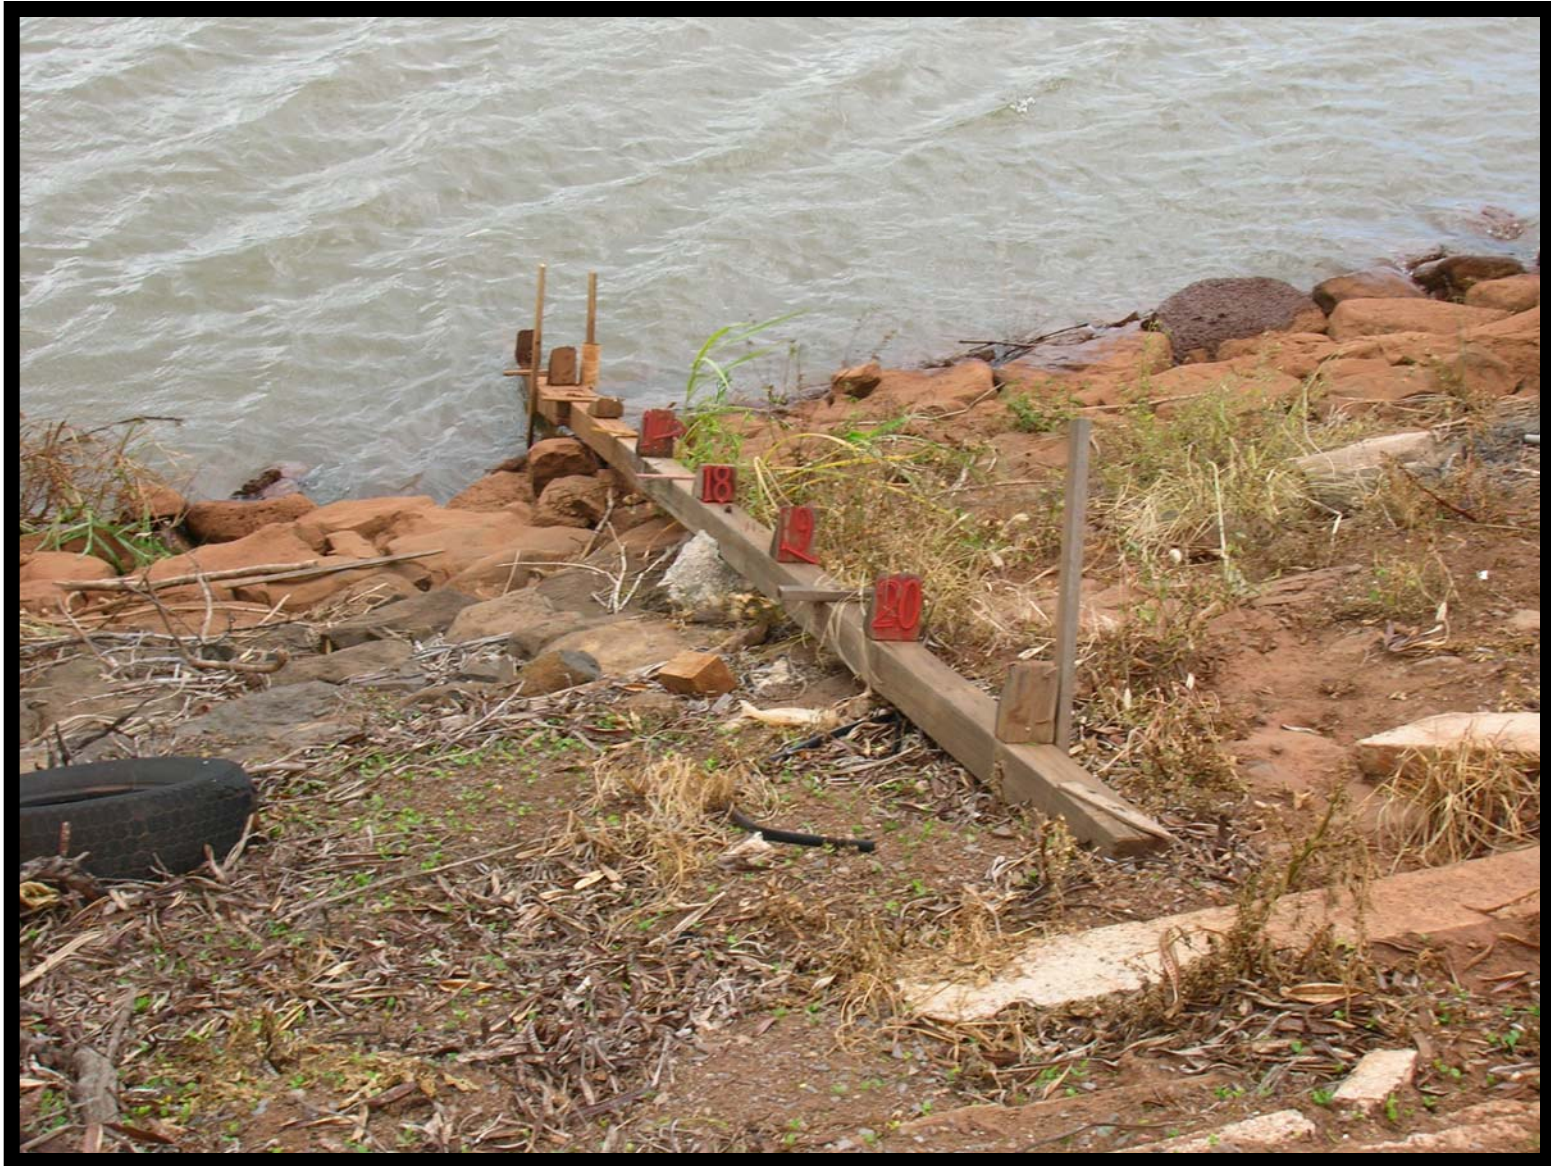
085 downstream slope 2

The downstream slope was in fair to poor condition and not visible due to heavy vegetation. The slope was a 1 on 2 slope.

Grasses, bushes and tress were observed on the downstream slope. .

- a. The downstream slope appeared to be in fair to poor condition and requires corrective action.
- b. The down stream slope was not visible due to high grass and bush vegetation. Clear high vegetation and maintain low to enable easy visual inspection.
- c. Tree(s) were observed on the downstream slope. Trees have been identified as the probably cause of piping failures, and can possibly cause sever damage to the embankment if they are uprooted during a high winds. Corrective action is required to remove the tree hazards from the dam. Acceptable remedies include removal of the tree and its root structure down to a 2" diameter and reconstructing the damaged embankment section. All repair work shall be accomplished as per the requirements of licensed geotechnical or structural engineer. Routinely monitor the damaged area for signs of settlement and seepage.
